**REQUEST FOR PROPOSAL  
for  
BUILDING DEMOLITION  
TOWN OF LAMONT**

Building Assessment Report – 2015  
Ptarmigan Engineering

Re: Dickens Building Assessment Report, 5131 - 48 Ave, Lamont, Alberta

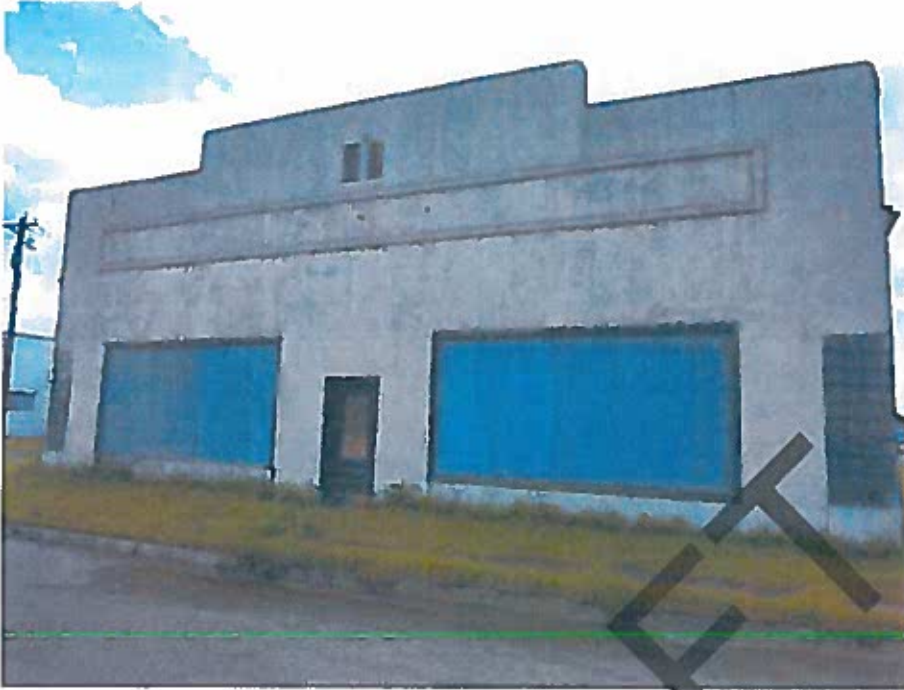
Photo P1  
View of north  
(front) wall  
exterior

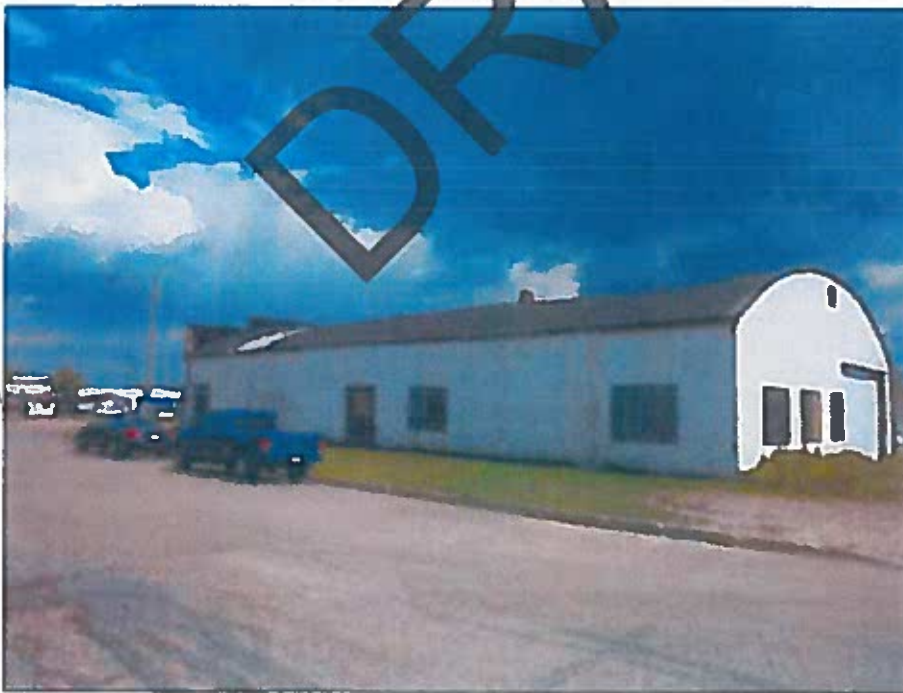
Photo P2  
View of west  
wall exterior

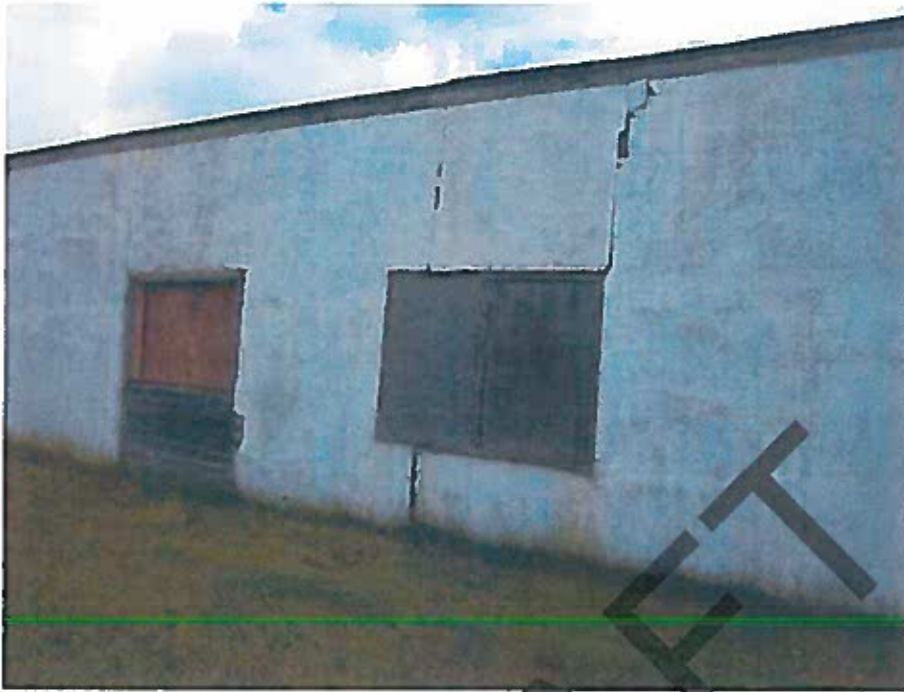
Photo P3

1. The stucco finish on the building exterior has deteriorated and is in very poor condition with numerous cracks and porous damaged areas (Photo P3).
2. Portions of the main building roof have sagged (Photo P4).

View of west wall exterior with poor & deteriorated stucco finish

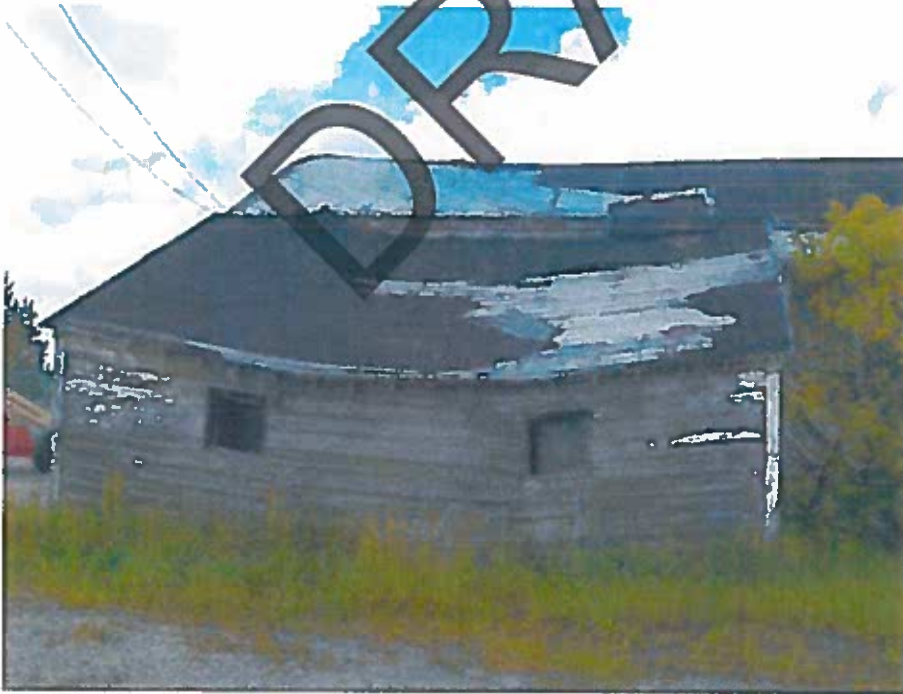
Photo P6

3. The roof of the lean-to structure has partially collapsed and is now perilously supported (Photos 5 & 6).
4. Generally, the walls were found to be reasonably plumb, however a number of local areas of the walls were misaligned.

View of lean-to  
with collapsed roof

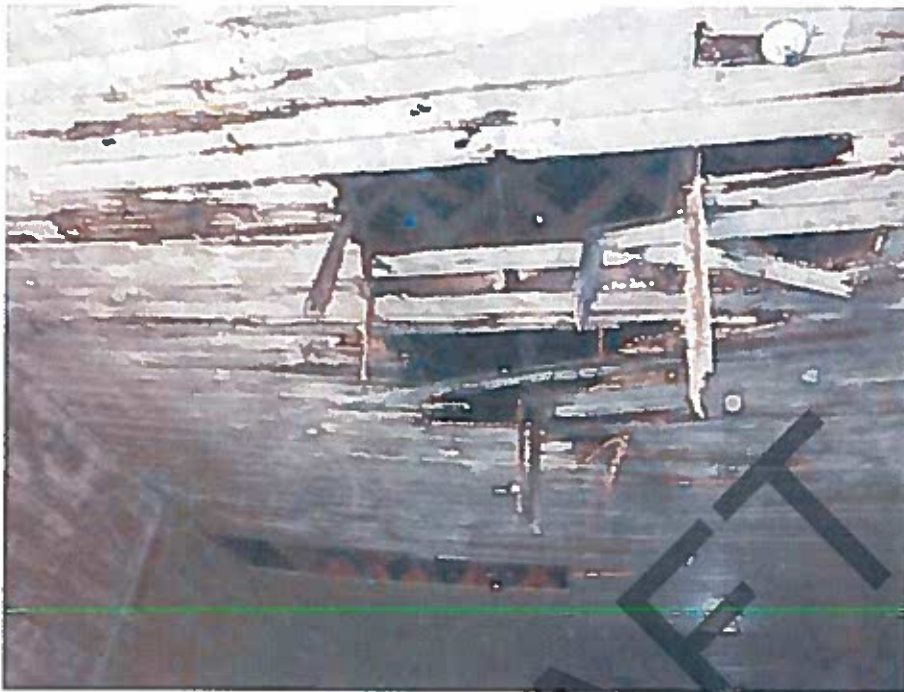
Photo P7

7. The building ceiling construction was found to be in very poor condition with many damaged areas. In some areas the ceiling had been completely removed. Most of the ceiling joists were found to be rotted and significantly deteriorated (Photos 7, 8 & 9).

View of typical damage to ceiling

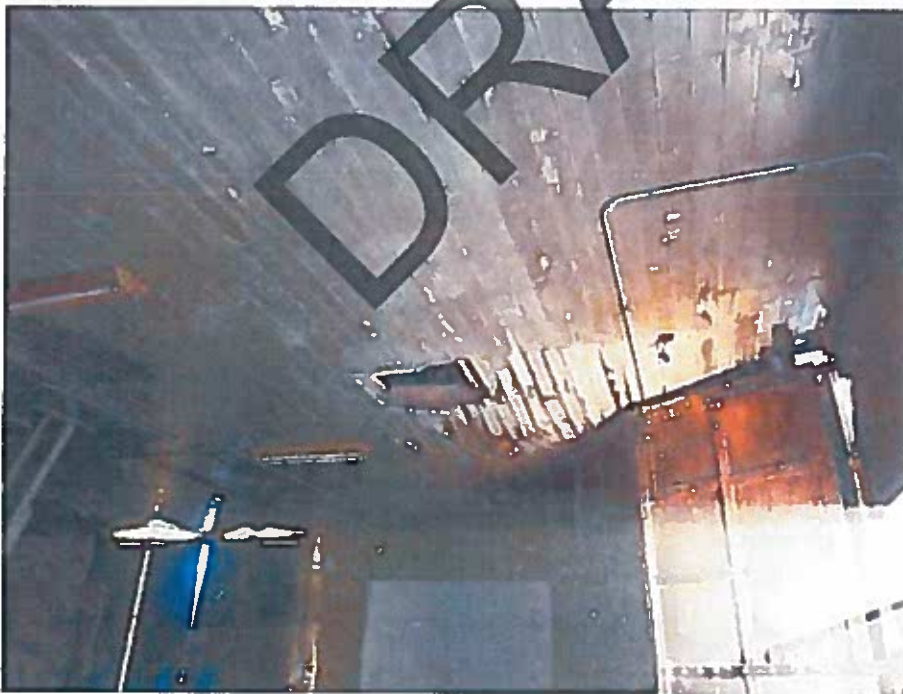
Photo P8

View of typical damage to ceiling

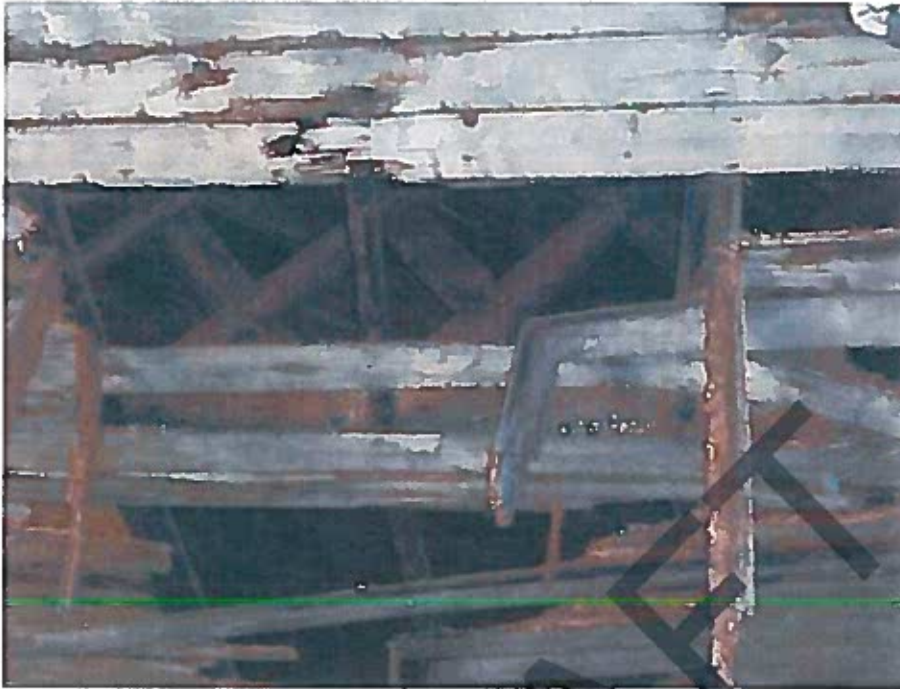
**Photo P9**

**View of typical  
damage to ceiling**

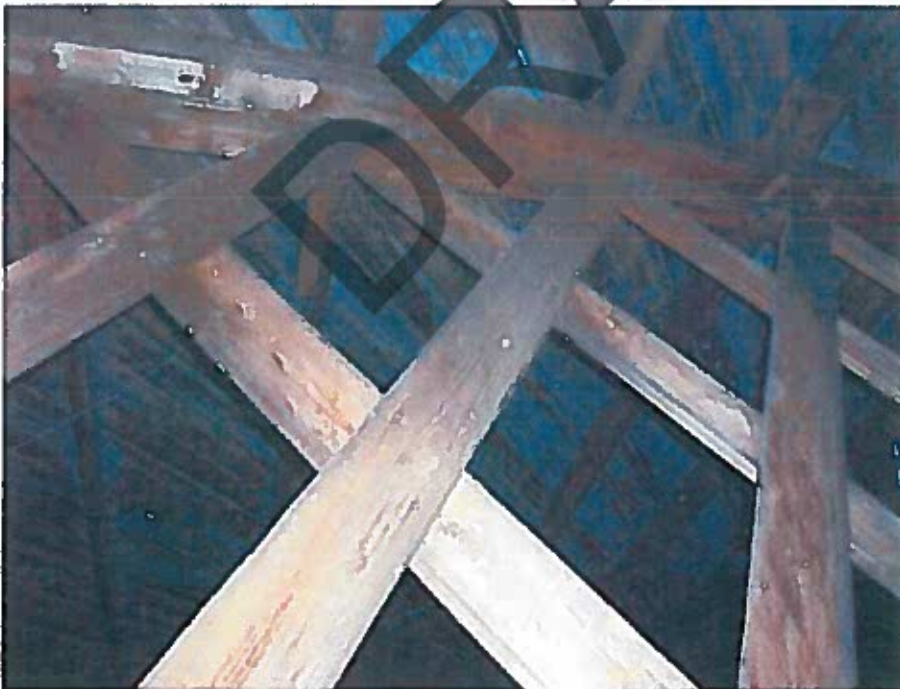
**Photo P10**

8. Due to the poor condition of the ceiling it was deemed unsafe to walk inside the building attic space, therefore restricting access to the trusses. However it was found that many local areas of the top and bottom chords of the trusses showed signs of moisture damage. It also appeared that the trusses were not plumb and have rotated slightly (Photos 10 & 11).

The lattice arch trusses are the primary structural elements that support the roof, and they were found to be sagging, partially deteriorated and in extremely poor condition. In this condition, the ability of these members to support the required snow loads is in serious jeopardy. To further compound the problem, with the loss of the ceiling, the trusses are no longer adequately braced against rotation and could fail simply by twisting under the snow load.

**View of underside  
of roof deck and  
top chord of  
lattice arch truss**

The building is in very poor condition, is not structurally sound, and poses a serious threat to human safety. Due to the infestation of pigeons, there is a strong possibility that the building poses a serious health concern to the surrounding neighborhood. In view of these findings, it is our opinion that the damage to the structure is well beyond economical repair, and the recommended course of action is that the building be totally demolished. Furthermore, given the poor condition of the materials and components, there is likely little or no salvage value to be recovered.

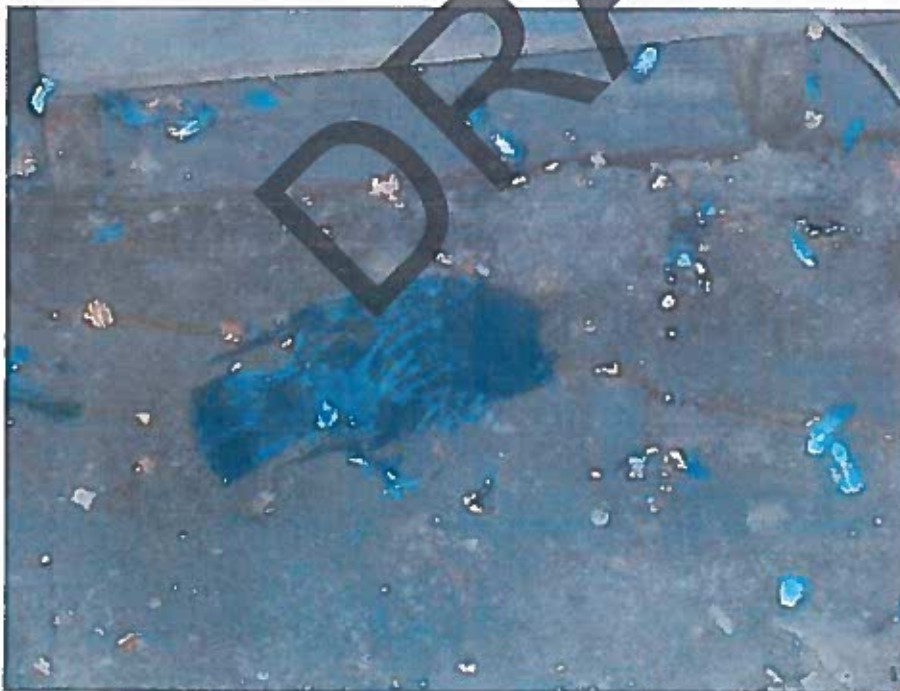
Photo P12

6. The building interior was found to be very unclean and inhabited with at least 100 pigeons, some were extremely sick, and others were dead. The floor was completely covered in debris and bird excrement (Photo P12).

View of typical  
condition of floor
